Corrosion of Low Carbon Steel in Chloride Containing Environment

Keywords: Corrosion, Low alloy steel, Chloride environment

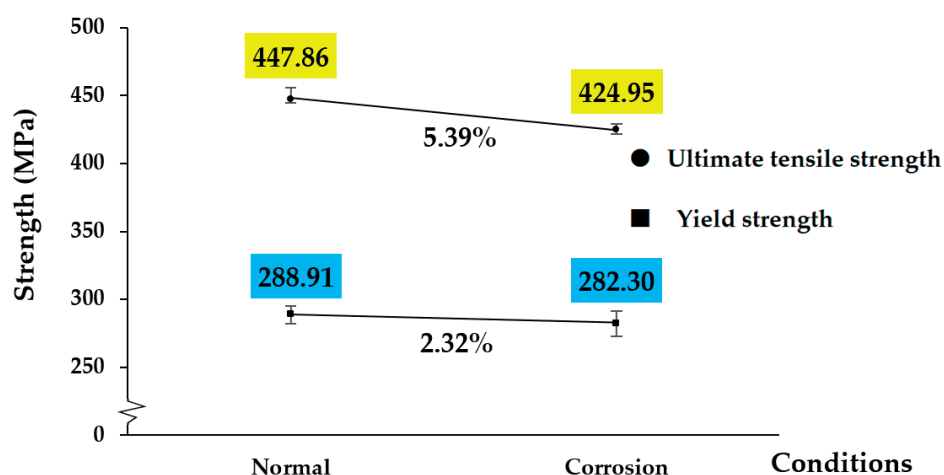
It was found that normal specimens have an average maximum tensile strength of 447.86 MPa, which is higher than that of corroded specimens with an average maximum tensile strength of 424.95 MPa. In the same way, the average yield strength of normal specimens is 288.91 MPa, while the average yield strength of corroded specimens is 282.30 MPa. Therefore, the average mechanical properties of normal specimens are higher than those of corroded specimens, as shown in Figure 3. If it is calculated as a percentage, it will be concluded that normal specimens have the average maximum tensile strength and the average yield strength higher than corroded specimens at 5.39% and 2.32%, respectively. Because the surface of corroded specimens is very rough due to corrosion products, tension loads acting on the corrosion pits will cause stress concentration and decrease the strength[8]. When the workpiece is subjected to tensile stress, it is easier to propagate some cracks. It can be noticed from the cracked surface, and it is a sharp tooth mark, as shown in Figure 4(A). When the tensile strength increases, the crack will propagate until the workpiece is completely fractured. While normal specimens do not have corrosion products on the surface, the fracture is caused by the ductile failure mechanism. The fracture surface is shown in Figure 4(B). Thus, it has a strength higher than the corroded workpiece.

Figure 3. Average mechanical properties comparison between normal and corroded specimen

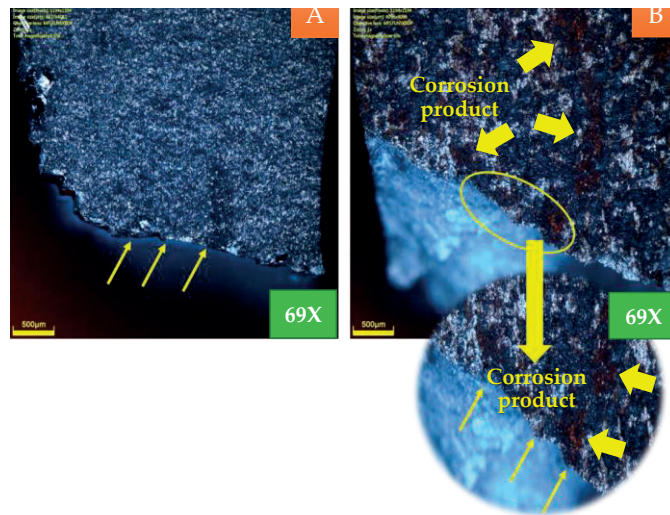
Figure 4. Fracture surface analyzed by optical microscope comparison between (A) Normal specimen and (B) Corroded specimen

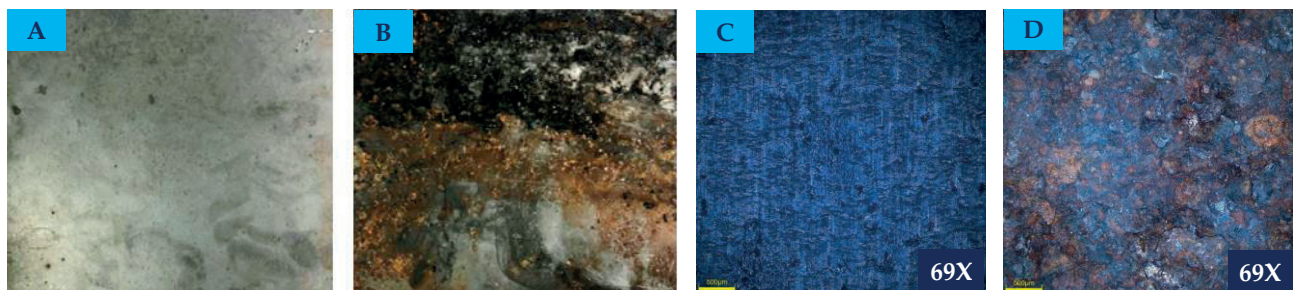
The surface condition of normal and corroded specimens, observed with visual and light microscopy, is shown in Figure 5. It can be seen that the normal specimens' surface is matte and does not peel off. As for the corroded workpiece, the surface of the workpiece is rough, and some area of the specimen's surface is peeled off. Also, it is found corrosion products when examined by scanning electron microscopy. As shown in Figure 6, it was found that the surface of the normal specimen is smooth and dull. Small scabs may be found on the surface in some places resulting from the hot rolling process. As for corroded parts, the workpiece's surface is rough and peeled off.

Figure 5. Surface investigation of specimens by visual examination (A) normal specimen, (B) corrosion specimen, and by optical microscope (C) normal specimen (D) corroded specimen

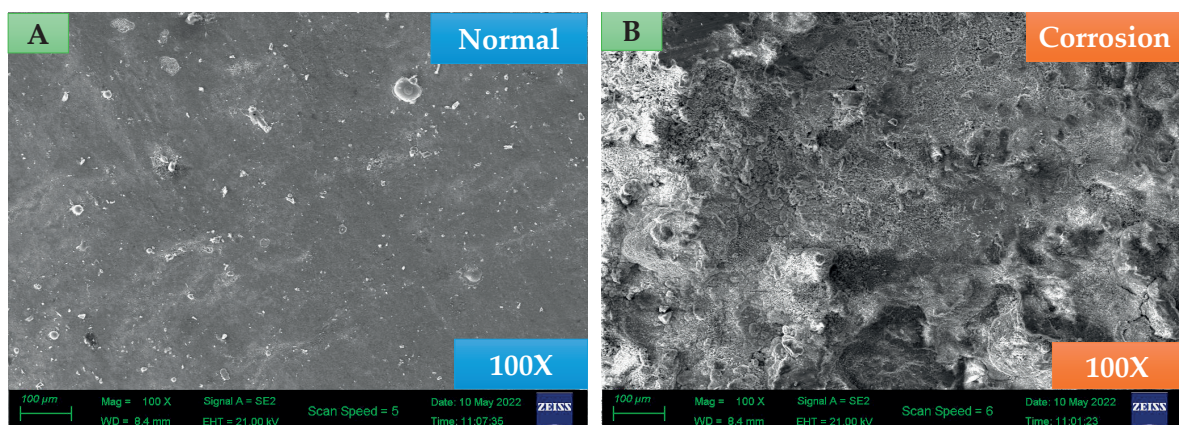
Figure 6. Surface morphology analyzed by FESEM (A) normal specimen (B) corroded specimen

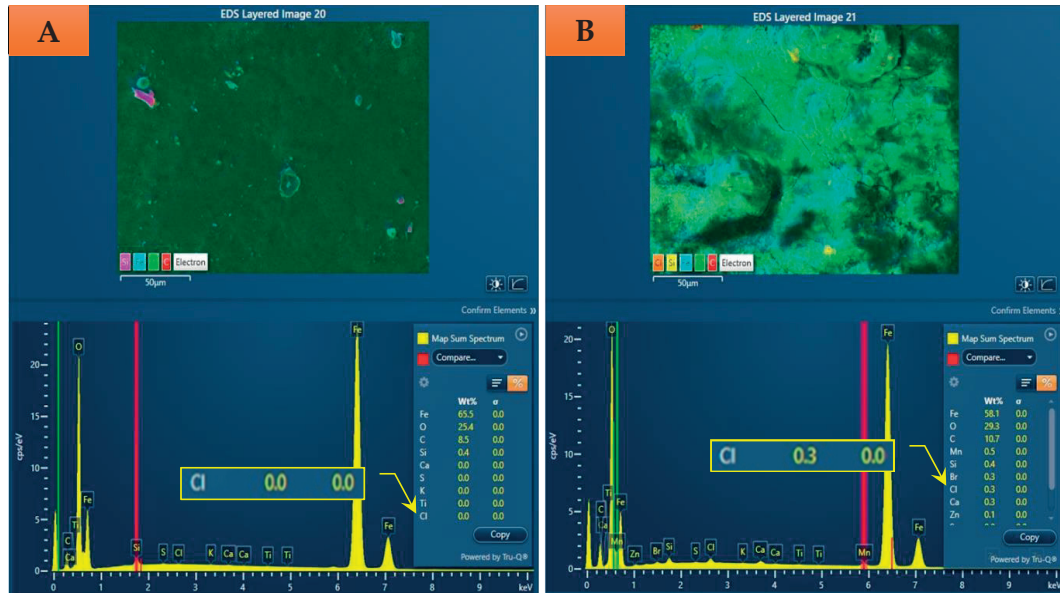
The microchemical composition examined by EDS is depicted in Figure 7. It shows that the normal surface of the specimen is composed of iron, oxygen, carbon, and silicon, while the surface of the corroded specimen contains the same elements as the normal specimen except chlorine. It was detected on the surface of the specimen. Chlorine is one of the main elements that potentially cause corrosion in steel [6]. The effect of chlorine on corrosion is studied next.

Figure 7. Microchemical composition of the specimen surface analyzed by EDS (A) Normal specimen (B) Corroded specimen

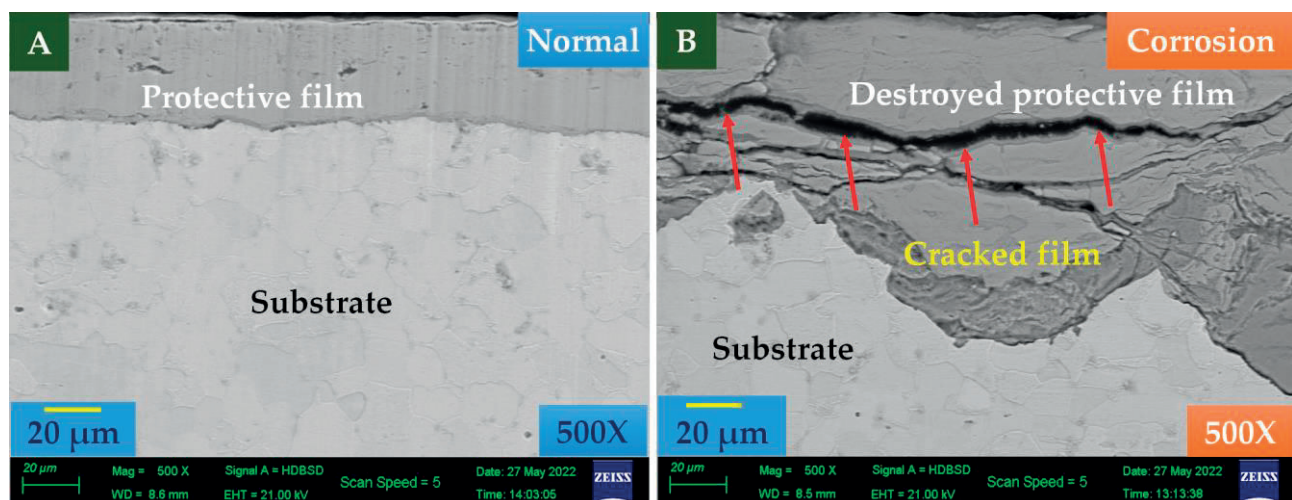
A detailed investigation of the surface, especially at the protective film, was performed, as shown in Figure 8. It was found that normal specimens have a protective film coating on the surface. An oxidation reaction formed the film layer during the hot rolling process (Figure 8(A)). In contrast with corroded specimens, the protective film is destroyed. The film contains several cracks separating the protective film from each other. This phenomenon allows the metal surface to contact the corrosive environment directly. Therefore, oxidation reactions still occur continuously. So, the film layer of the corroded specimen is not only a result of the hot rolling process, but it is also caused by an oxidation reaction when the substrate is exposed to the corrosive environment. That explanation can also explain why the film thickness of the corroded workpiece is greater than the normal specimen.

Figure 8. Morphology of protective film analyzed by FESEM (A) normal specimen (B) corroded specimen

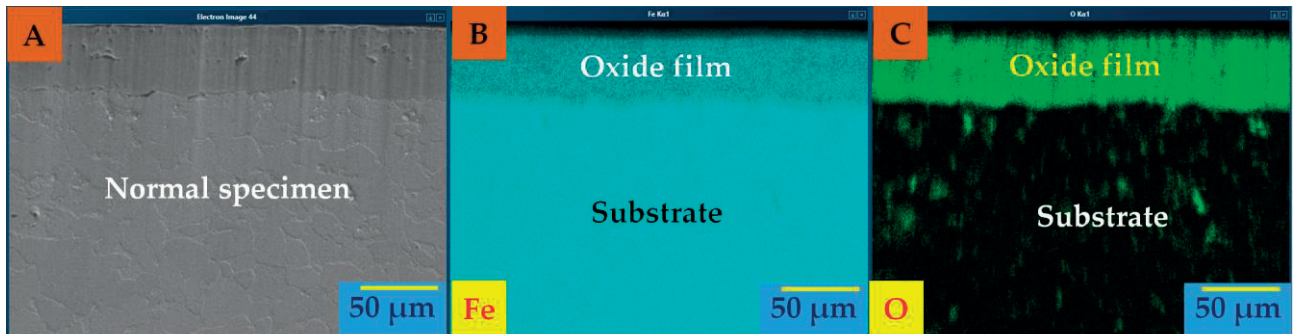
The microchemical composition of normal specimens is shown in Figure 9. It was found that the protective film formed by the hot-rolling process was mainly composed of iron and oxygen. It is ferrous oxide. Moreover, it was observed that the iron content in the oxide film region was greater than that in the substrate. The substrate is composed of many elements within it. Therefore, as a proportion, the iron content is greater in the film layer area.

Figure 9. EDS mapping of cross-section's surface normal specimen (A) SEM micrograph (B) iron (C) oxygen

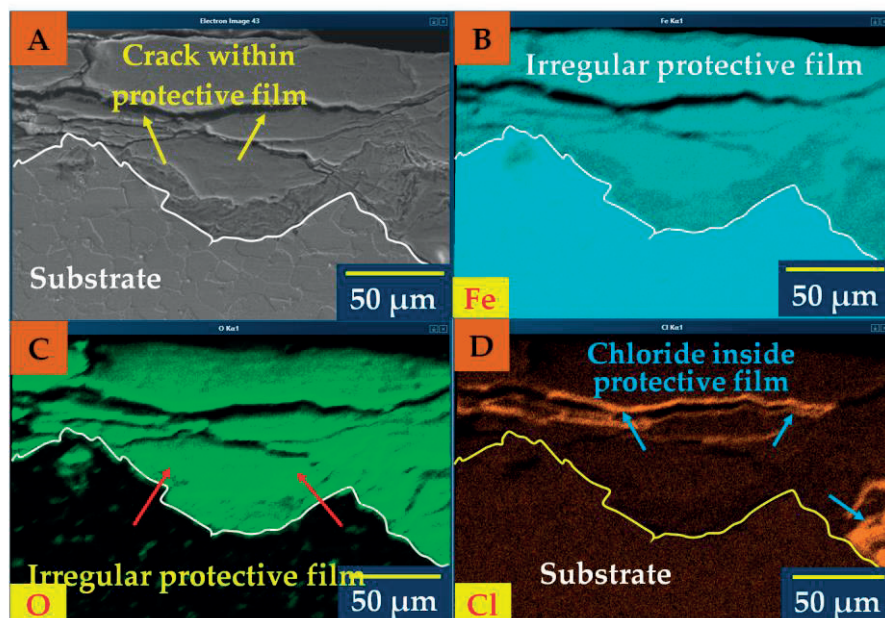
The oxide film layer is cracked in corroded specimens. However, the chemical composition is not quite similar to the normal specimens. Iron, oxygen, and chlorine are found in the oxide film. It remains similar to the composition of the corroded specimen's surface, as shown in Figure 10. Therefore, the oxidation of steel, despite the presence of chlorine, will continue to form compounds composed of iron and oxygen because the protective film is porous (Even though it has been hot rolled, making the film denser). This allows the chloride ions to easily pass through the film and react with the substrate resulting in a thicker and deeper oxidation film. However, if the oxidation layer is complete, it will inhibit chloride corrosion [6]. Chloride plays a vital role in catalyzing the oxidation of steel.

Figure 10. EDS mapping of cross-section's surface corroded specimen (A) SEM micrograph (B) Iron (C) Oxygen (D) Chlorine

Because the chloride ion catalyzes the oxidation reaction of steel, following Equations 1 – 2, resulting in an increment in both classification and quantity of corrosion product. This is consistent with the analysis results shown in Figure 10.

1. A suitable pre-treatment or surface coating on a bare carbon steel surface would help inhibit corrosion. It prevents the access of corrosive anions to the steel surface [10-12].
2. Avoiding direct exposure to chloride-containing atmospheres can suppress and prevent corrosion, even though low-carbon steel can be slightly corroded in the natural environment caused by humidity and dissolved oxygen [13-14].
