Maejo International Journal of Energy and Environmental Communication

Corrosion analysis of API X70 steel in seawater environment

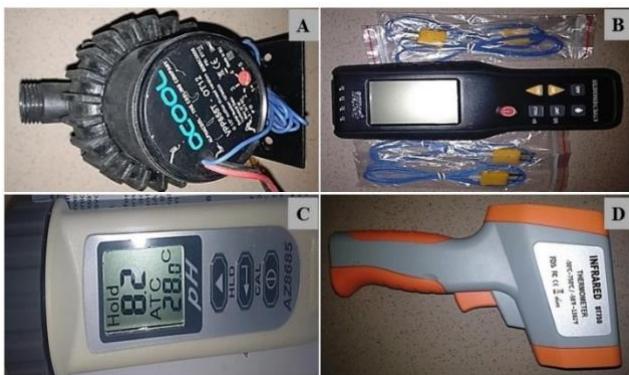
Figure 1. Water circulation pump (A), digital thermometer (B), digital pH meter (C), and IR thermometer (D) are used in the corrosion rig to help collect the necessary data.

This investigation mainly relies on a 600 x 150 x 20.8 mm API X70 steel plate. The manual metal arc welding was done at SCC Nig. Ltd. in Ushafa, Bwari, and FCT Abuja. The researchers used many pieces of equipment and materials like a corrosion rig, a chiller, thermometers, pumps, a pH meter, digital microscopes, a tensile test machine, an Izod impact test machine, a Vickers hardness machine, a grinding and polishing machine, a scanning electron microscope (SEM), X-ray fluorescence, and X-ray diffraction machines for this study (Figure 1).

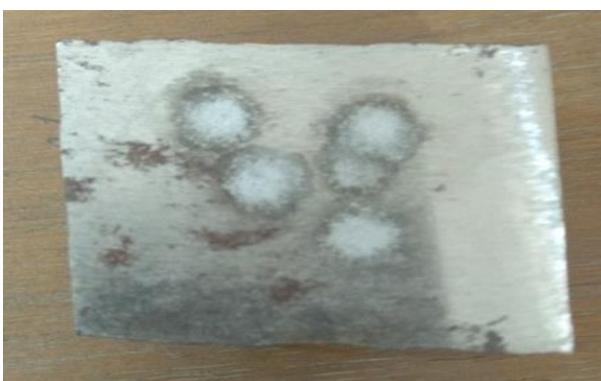
Figure 2. Surface of API X70 steel sample after chemical and spectroscopic analysis

Characterization and Spectroscopic Analysis with the API X70: At Oshogbo Machine Tools, they use chemical analysis to determine the chemical composition of the steel plate. Spectroscopy was carried out to determine the elements and types of materials present in the steel (Figure 2).

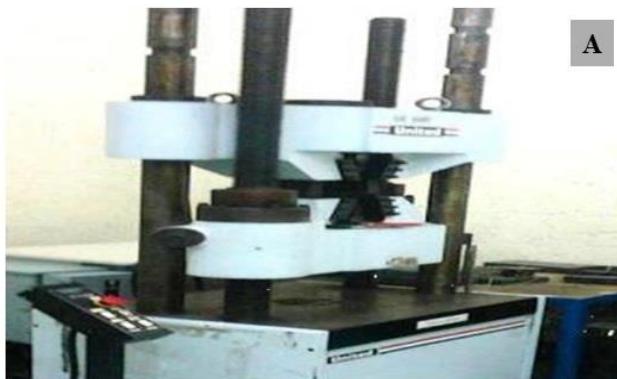
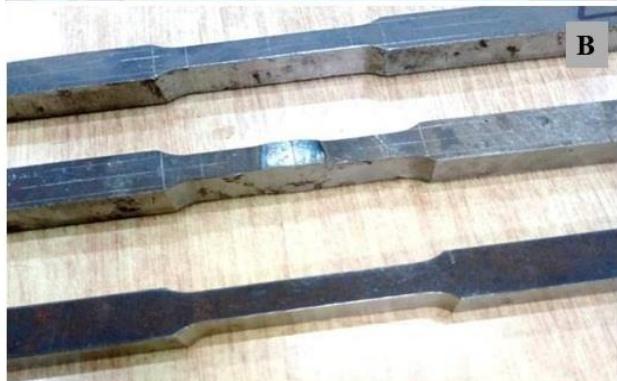
Figure 6. Tensile testing setup for API X70 steel: (A) UTM for tensile tests per ASTM E8/E8M standards and (B) Standard tensile specimens from weld zone, HAZ, and parent material of steel plate

Stress testing was done to observe how API X70 steel samples operated in regular air and in seawater (Figure 6). By following ASTM E8/E8M rules, the tests used dog-bone specimens from weld metal, HAZ, and parent material. The samples chosen were put in synthetic seawater to see how corrosion could degrade them. To test, the universal testing machine (UTM) was used, and the ultimate tensile strength (UTS), yield strength (YS), elongation at break, along with the modulus of elasticity, were recorded. The curves showing stress against strain were studied to observe how each area of the weldment reacted to being in a marine environments.

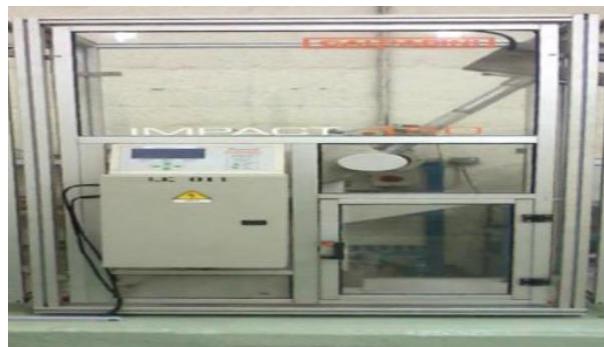
Figure 7. Charpy impact testing machine used for toughness evaluation

checked by impact testing that followed the standards from ASTM E23. From every location of interest in the samples, standard Charpy V-notch specimens were taken for testing. Every fracture was done using a pendulum impact tester, and the measurements of the fracture energy were saved. They added insight into the material's possible brittle failure after it was put into marine environments. Impact tests were done on API X70 steel by using the apparatus based on ASTM E23 standards. The quantity is obtained by knowing how much energy is taken up during bone fracture at high rates of strain (Figure 7).
