# Evaluation of Combustion Grate Damage: A Comprehensive Review of Grate Deterioration in Biomass Power Plants

Biomass-fired power plants in the VSPP scale increasingly rely on agricultural and woody residues, yet grate components frequently experience premature failure that leads to unplanned outages and high maintenance costs. This study provides a quantitative evaluation of grate-bar degradation mechanisms using long-term operational data, in-situ temperature measurements, and metallurgical characterization. Surface temperatures of 1000–1200 °C and radiative heat fluxes of 65–78 kW/m<sup>2</sup> were identified as the dominant thermal drivers of overheating, particularly in zones intermittently exposed during fuel-bed collapse. A six-year dataset from a 9.9-MW reciprocating-grate power plant, supplemented by laboratory material analysis and combustion-zone mapping, was used to identify the controlling failure modes. The results show that persistent primary-air (PA) maldistribution, unstable fuel-bed conversion, and periodic loss of ash/fuel coverage significantly increase radiative exposure and thermal cycling. Metallurgical examination revealed oxide-scale spallation, carburiz

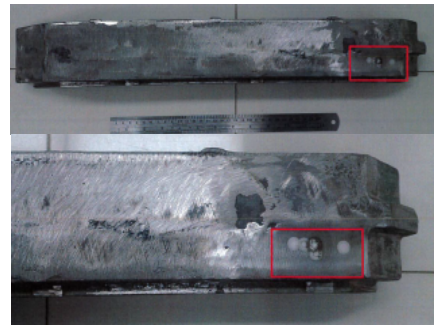
Two severely degraded grate bars were extracted from the furnace after eight months of operation for metallurgical and chemical analysis. The grate material was identified as austenitic cast stainless steel (DIN EN 10295 GX130CrSi29), a high-chromium, high-silicon alloy designed for elevated-temperature service and resistance to carburization and oxidation. Chemical composition was verified using an optical emission spectrometer (ASTM E351), and results were compared directly with DIN EN 10295 standard limits (Table 4). The OES test confirmed elevated silicon and

chromium mass fractions, which enhance oxidation resistance but also indicate potential microstructural changes caused by prolonged thermal exposure. Although nickel–chromium-based alloys are rated for 900–1150°C, field measurements revealed grate-surface temperatures reaching 1000–1200°C, exceeding continuous-service limits and accelerating creep and thermal-fatigue phenomena [6]. Microstructural examination further showed oxide-layer spallation and intergranular attack in high-temperature zones, consistent with corrosive degradation mechanisms observed in prior studies. These effects were strongly correlated with localized radiation hotspots and oxygen-deficient microenvironments, which intensified carburization and contributed directly to premature grate failure [4].

**Fig. 9.** Overall photograph of the Grate bar using the optical emission spectrometer (OES) test method.

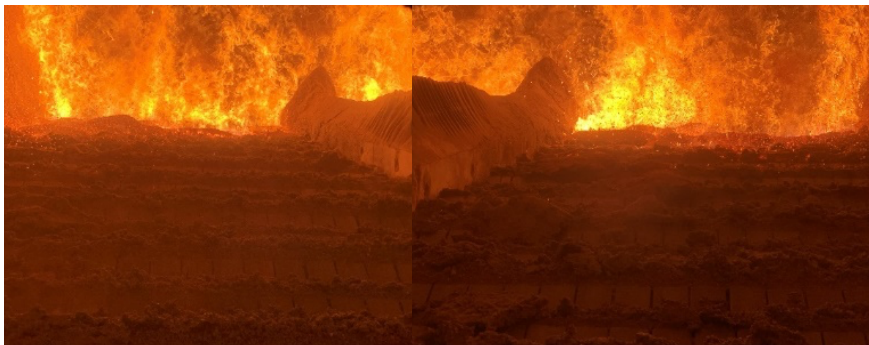
16, the highest damage concentration occurred in Zones 1–2, which aligned with areas receiving elevated primary-air flow and experiencing strong radiative loading due to incomplete fuel coverage. These findings directly link airflow distribution and fuel-bed instability to localized grate overheating.

**Fig. 14.** The high combustion grate zone.
