## EFFECT OF HOLE DRILLING PROCESSES ON SERVICE LIFE OF BUCKET USED IN BUCKET ELEVATOR

### ABSTRACT

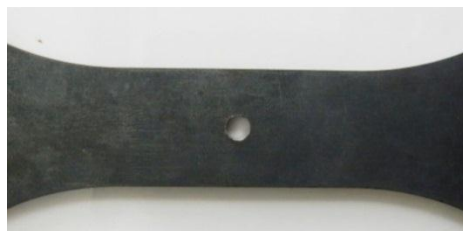
**Figure 5** Original surface color of fatigue test specimen before grinding.

The color of the original surface of the test specimen is shown in Fig. 5. The quality of the drill surface can be seen in Fig. 6, for the SD, SNC and ENC methods. The degrees of roughness of the hole with different fabrication methods are clearly observed. The roughest surface came from the SD method. These uneven screw marks which were known as the location for high stress concentration were easily visible. The uneven and scratch marks have effect on the service life of the bucket and will be discussed in the topic 3.3. The SNC produced sample has fewer defects and scratches when compared with the SD sample. For the ENC sample, a shiny smooth surface was observed.

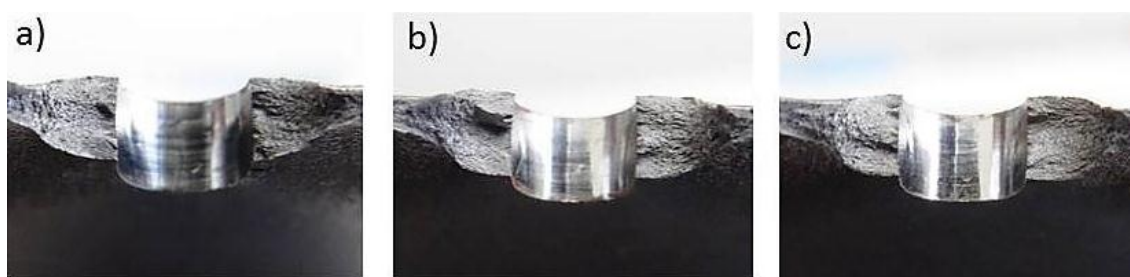
Fracture surface observation of three types of failed specimens tested at high stress amplitude was compared in Fig. 9. Crack initiation and propagation were in the direction perpendicular to the longitudinal direction of the specimen. At high stress level, numbers of cycles to failure of three types of drilling process were dense in a narrow region. Also, fracture surfaces of the three types of drilling process show similar characteristics; those are clearly visible as ratchet marks. In the case of low stress amplitudes, ratchet marks were visible for the SD specimen, while the SNC and ENC specimens were not, as shown in Fig. 10.

**Figure 9** Fracture surface of a) SD, b) SNC and c) ENC fatigue specimen tested at stress amplitude of 123 MPa.
