Structural Durability Assessment of Stilt Houses to Flash Flooding: Case Study of Flash Flood-Affected Sites in Thailand

Olarn Charoenchai^{1,2,*} and Kampanad Bhaktikul¹

¹Faculty of Environment and Resource Studies, Mahidol University, Nakhon Pathom 73170, Thailand

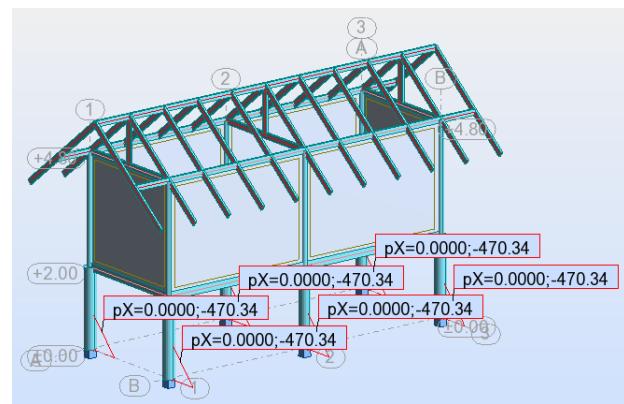
Figure 2. Example of basic graphical model of stilt house with applied flood loads on its downstairs columns.

The assessment of structural sturdiness of stilt houses to flash flooding was conducted using software named Robot Structural Analysis Professional (Educational Version) ([Autodesk, 2015](#)). This software is an integrated program used for modeling, analyzing, and designing various types of structures. Data from the field surveys could be used to categorize the stilt houses into seven types. The physical appearance of each type was simplified and used as raw data to generate basic graphical models for testing structural durability. Flood loads were calculated and then applied to the models ([Figure 2](#)).

The software processed and analyzed data and then showed the responsive stresses at any point on the main structure of the model. Such reactive stresses were compared with the ultimate strength of the material being used in the main structure. If the reactive stress is less than the ultimate strength, then the main structure of that house can resist flood loads. Conversely, if the reactive stress is higher than the ultimate strength, then the main structure is likely to be damaged by flood loads.

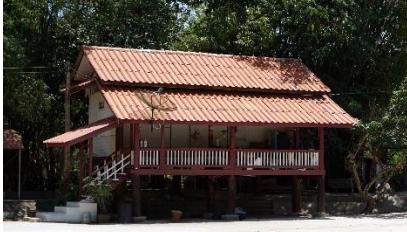
Wooden roof structure, square wood columns 15×15 cm, wood walls, and wood floors (upstairs), round wood columns diameter 30 cm and earth ground (downstairs).
Type I

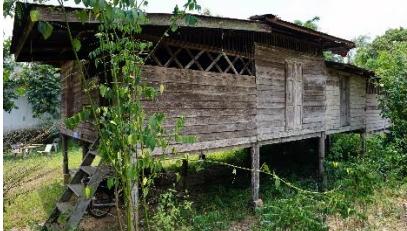
Wooden roof structure, round wood columns diameter 15 cm, wood walls, and wood floors (upstairs), round wood columns diameter 15 cm and earth ground (downstairs).
Type II

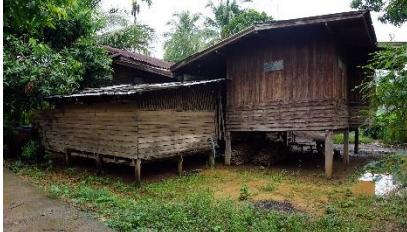
Wooden roof structure, square wood columns section 15×15 cm, wood walls, and wood floors (upstairs), square wood columns section 15×15 cm and earth ground (downstairs).
Type III

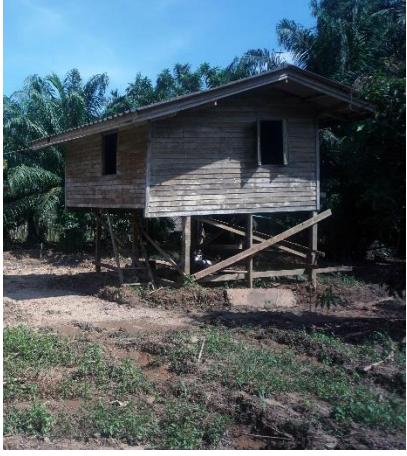
Wooden roof structure, square wood columns section 15×15 cm, wood walls, and wood floors (upstairs), square wood columns section 15×15 cm, bracing wooden bars, and earth ground (downstairs).
Type IV

Third, diagonal and horizontal bracing members, fixed among stilt columns and perpendicular to the flow direction of floodwaters, were nearly useless if they were not above the flood level. Instead of permitting floodwaters to flow through rapidly, such bracings became water obstructions which increased reactive stresses and resulted in a high risk of severe damage to the core structure of the house. This does not mean that bracings are not permitted but rather that diagonal and horizontal bracing elements should be aligned in parallel with the water flow direction and installed above flood height so they do not hinder the flow of floodwaters and can increase the strength of the main structure to resist lateral forces (flood loads) efficiently. This finding corresponded to [Liao et al. \(2016\)](#) who studied stilt houses in the Vietnamese Mekong Delta, especially in areas subjected to floodwaters that coincided with a storm to produce waves that could collapse the house. They found that to mitigate the flood hazard, many households in those areas reinforced their stilt houses by tying bamboo poles between the stilts. [Dilhani and Jayaweera \(2016\)](#) mentioned attributes of flood risk mitigation strategies in dwellings, with one being to strengthen the main structure of the house by using bracing members. They suggested bracing of the adjacent posts diagonally in order to keep the house from leaning. [Parekh \(2018\)](#) reported that where a building is constructed so that the lowest floor is elevated above the regulatory flood height, the stilts should be compact and free from unnecessary appendages which would tend to trap or restrict free passage of debris during a flood. Bracing, where used to provide lateral stability, should be of a type that causes the least obstruction to the flow and the least potential to trap floating debris. [Chaves \(2015\)](#) stated that the horizontal structural members of the building not above the flood height are considered to be obstructions that can transmit the force of water impacts to the rest of the structure.

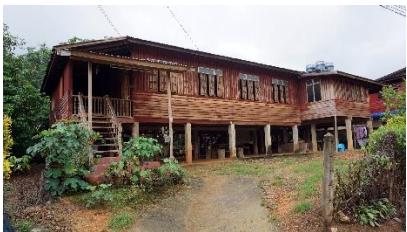
Type V

Wooden roof structure, square wood columns section 15×15 cm, wood walls, and wood floors (upstairs), square concrete columns section 20×20 cm and concrete floor slabs on ground (downstairs).

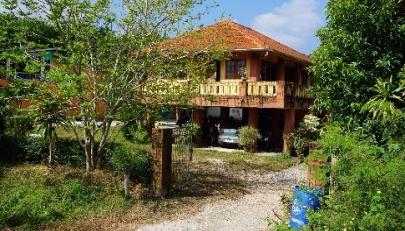
Wooden roof structure, square concrete columns section 20×20 cm, bricked walls, and concrete floor slabs on beams (upstairs), square concrete columns section 20×20 cm and concrete floor slabs on ground (downstairs).
Type VI

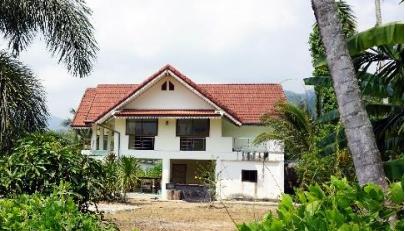
Wooden roof structure, square concrete columns section 20×20 cm, bricked walls, and concrete floor slabs on beams (upstairs), square concrete columns section 20×20 cm and concrete floor slabs on beams (downstairs).
Type VII

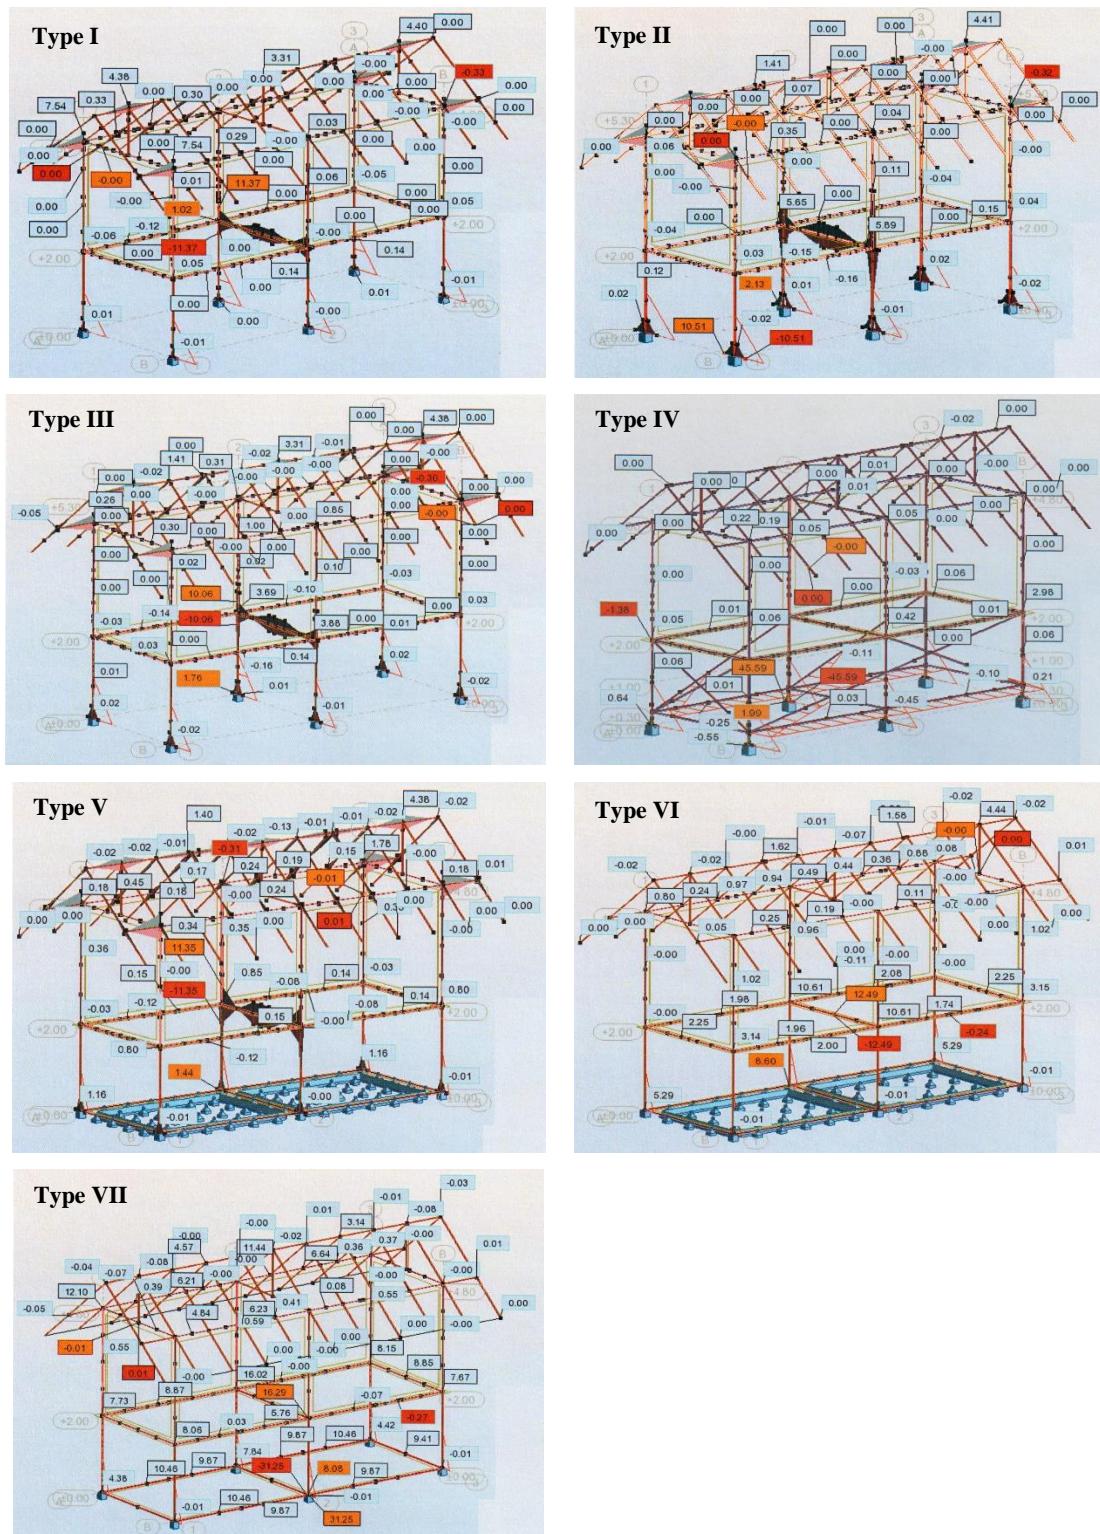
main structure of the house reacts by generating responsive stresses at all points of its components as shown in [Figure 3](#). The marks “-” and “+” do not represent the numerical meaning, they just indicate the type of stress that is compressive if a negative sign and tensile if there is a positive sign.

Figure 3. Reactive compressive and tensile stresses at any points of main structure of each type of stilt house, when struck by moving water at downstairs columns

The downstairs columns of stilt house Types V and VI were made of concrete and the testing results of structural durability revealed that the highest compressive and tensile stress in their main structure when hit by flood loads were not beyond the ultimate compressive and tensile strengths of the concrete. Stilt house Type V responded to flood loads by establishing reactive compressive and tensile stresses of -11.35 and $+11.35 \text{ kg/cm}^2$, respectively, at one joint of the column and stilt floor beam, whereas pillar house Type VI generated reactive compressive and tensile stresses of -12.49 and $+12.49 \text{ kg/cm}^2$, respectively at one stilt floor beam made of concrete. Such values were not over the respective maxima of 18 kg/cm^2 and 180 kg/cm^2 indicating that the main structures in these two types of stilt house could tolerate flood loads. Similar to Types V and VI, the downstairs piles of stilt house Type VII were concrete and the highest compressive and tensile stresses (each being 31.25 kg/cm^2) occurred at the bottom of one column. Regarding compression, 31.25 kg/cm^2 is much less than the ultimate compressive strength of concrete (180 kg/cm^2), so these columns could resist compressive loads induced from floodwaters. Regarding tension, 31.25 kg/cm^2 is greater than the critical tensile bearing capacity of

concrete (18 kg/cm^2), indicating that this concrete column in stilt house Type VII would likely be damaged due to the stress of tension. The field surveys revealed that in fact every column of this type of stilt house still existed without any damage. In practice, the core structure of the house was not made of pure concrete, but rather was reinforced concrete containing steel bars or rods within the concrete to increase the tensile strength of the concrete core structure. Engineers know well that concrete has a very limited capacity to bear tension, so they put reinforcing steel bars inside the concrete to absorb tensile stress instead, because of the very high ultimate tensile strength of steel.

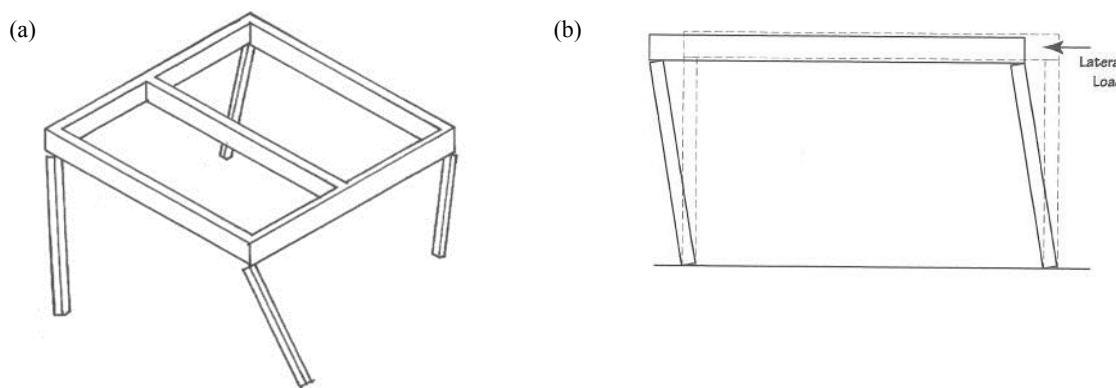
and horizontal structural members are always the weakest points of the post and lintel structural system of a stilt house because they are the first point that will sway and move and then get damaged when struck by a lateral force. This is consistent with [Allen et al. \(2010\)](#) who studied lateral load resistance capacity in a bay of framing. They remarked that a bay of framing (a post and beam system) is mainly designed to resist axis or gravity loads. If a lateral load is applied to a bay of framing with ordinary joints, the bay will deform and collapse with a twisting motion and the top of a column that connects to a beams and the foot of the column will slide from its position. Such lateral load tends to push over beams and columns and then separate them ([Figure 4](#)).

Figure 4. (a) Unbraced bay of framing will often collapse with a twisting motion; (b) lateral load tends to push over a beam and column (Allen et al, 2010)

Therefore, strengthening should be done to the base of the column and the joint between the column and the stilt floor beam in order to make the main structure of the house more resistant to any moving water force. Several studies have implied that the bottom of the post and the junction between the post and beam are the weakest points when struck by flood loads as well as remarking on how to make those weakest points more resistant to water force. [Stephenson et al. \(2018\)](#) indicated that the effect of lateral pressure from floodwaters is considered in relation to the resistance of the structure to being washed away. Concerning wash out, the connection of the structure to the foundation is a significant factor, since the friction action of the embedment of the post to the foundation is considered to resist flood loads and provide vulnerability reduction. [Dilhani and Jayaweera \(2016\)](#) found that reinforcing the superstructure of the house is one effective method to reduce flood damage. The building structure should be fixed to strong and deep foundations. The base of columns should not be free standing, but rather vertical
