A Case Report on Root Cause Analysis of No-Go Parts in Refrigerator Factory

Abstract—This paper studies the causes of customer complaint to a refrigerator manufacturer. No-Go (NG) product in manufacturing process not only affects the manufacturing cost but also increase problem about waste management. Main potential cause was identified with Quality Control (QC) tools and Failure Mode and Effects Analysis (FMEA), and it was weakness of legs of cooling blower shroud after injection process and unintended dropping of the blower in assembly station. To proof the hypothesis, the first stage of investigation with Finite Element Analysis (FEA) was performed with the drop test at the height of 0.8 m with impact angle of 45 degrees from the level of an assembly table. According to convergence testing of the FE analysis, the results were well consistent with the found deflection. The FEA exhibited the stress of the model of dropping height was 135.6 MPa which almost reached the ultimate stress of the blower material. Therefore, an improvement was done by setting the assembly level at 10 cm lower to diminish the kinetic energy of unintended dropping while transferring. After the improvement

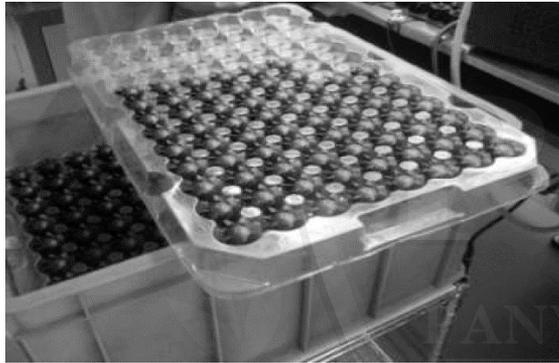
FMEA in the second step is tabulated in Table I. The RPN column shows that unintended impact during assembly has the highest priority which its value is 180. This is because during inspection of the assembly process, it was found that the operators used conveyor table to transfer finished part in the assembly station with height of 0.8 m above ground, as seen in Fig. There is high chance that finished part will fall to the ground which results in mechanical failure. The authors decided to use Finite Element Analysis (FEA) to verify the hypothesis of unintended impact during assembly.

Fig. V. The improper installed position of a blower packaging box and the level of assembly table.

To solve the highest priority of causes that cause NG products, due to the FEA result, the assembly line is improved by reducing kinetic energy that the leg of blower shroud will absorb. Hence, the level of the assembly table was reduced by 10 cm and the direction of placing the workpiece box is changed to ease ergonomically working.
