## The Study on High Temperature Degradation of AISI 1020 Low Carbon Steel in the Carburization State

### Abstract

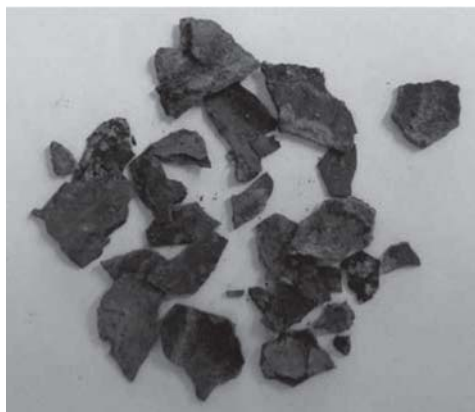
**Figure 3** Oxide scales spalling from the surface of the aged specimen

Normally, the oxide product layers in of steel under the simulated oxidizing / carburizing environment are discontinuous and loosely adhered to the surface (Jones, 1992). Thus, it is non-protective. The different thermal expansion of steel can potentially enhance the spalling of the corrosion scales (McCafferty, 2010), as displayed in Figure 3. The prolonged exposure time and the increase in the number of the exposure cause the rapid formation of the oxide scales.

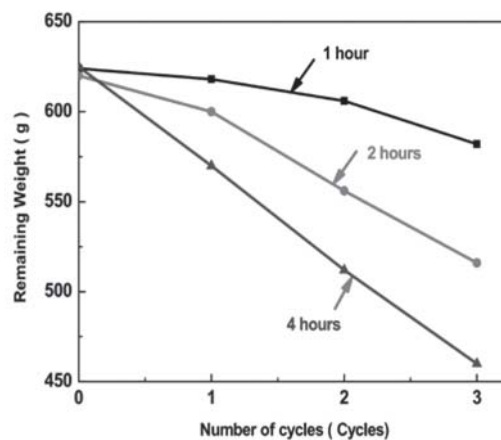
The variation in the weight of the steel samples after the simulated oxidizing / carburizing environment with the different holding times and number of exposure is shown in Figure 4.

**Figure 4** The variation in the weight of the steel specimens exposed to the simulated oxidizing / carburizing environment with the different holding times and number of exposure

**Figure 5** The microstructure of fresh specimen from Figure 4, the weight of specimens basically decreases after exposure and when the exposure time is longer and the number of the exposure is increased, the weight of specimen significantly decreases

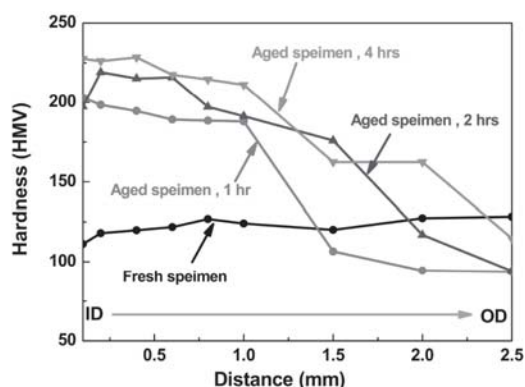
**Figure 7** The hardness profile of the fresh specimen and aged specimens after exposure to the simulated oxidizing/carburizing environment at 1000°C with different holding times of 1, 2 and 4 hrs

Figure 7 shows the hardness profile of the fresh specimen and aged specimens after exposure to the simulated oxidizing/carburizing environment at 1000°C with different holding times of 1, 2 and 4 hrs. The hardness measurement was carried out from the inside to the outside of the specimen (0.1, 0.2, 0.4, 0.6, 0.8, 1.0, 1.5, 2.0, and 2.5 mm). It can be seen from Figure 7 that the hardness of all positions increases with increasing in the holding time. Usually, the presence of carbides and carbide networks in steel increases the hardness of steel (Xinga et al., 2006). Hence, the formation of carbide and carbide networks observed from the microstructure evolution in region (I) and (II) of Figure 6 contributes to the increased hardness of aged samples. However, the hardness tends to decrease

with increasing in the distance from the inside of the specimen. Besides, after the distance around 1.5 mm from the inside of the specimens, the hardness tends to significantly decrease and becomes less than that of the fresh specimen. Normally, low carbon steel can be greatly degraded after exposed to the high temperature oxidation environment (Chowwanonthapunya et al., 2016) Oxidation, decarburization and grain growth can possibly occur (Anzel et al., 2012) and then deteriorate the desired mechanical properties of steel, particularly hardness and strength (Rahmel et al., 1998) Thus, the degradation of steel subjected to the high temperature oxidation environment accounts for the decreased harness profile. All findings are in agreement with Figure 6 that the different microstructure results in the different harness.

of the pipe specimen was clearly noticed, which can be ascribed to the change in the chemical compositions in the different carburizing stages. The hardness profile suggested that the highest hardness was found at the inside of the specimen and it gradually decreased with increasing in the distance from the outside of the specimen.
